2024 Annual Inspection Report Unit 3A/B Impoundments

For Compliance with the EPA Coal
Combustion Residuals (CCR) Rule
40 CFR §257.83(b)

Former J.B. Sims Generating Station

August 15, 2024

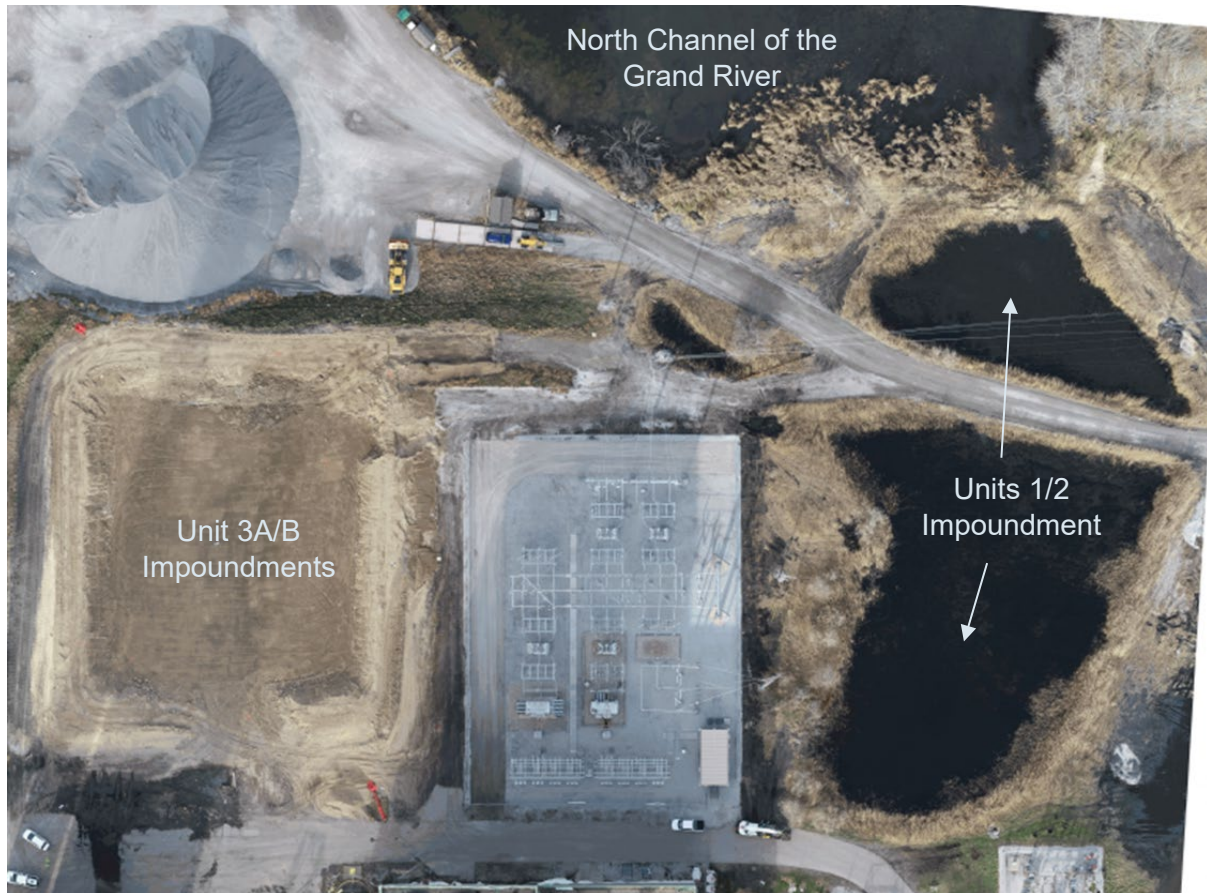
Figure 2. Site Configuration

The Site is a former coal-fired power generation facility which ceased operations in February 2020. CCR generated at the former generating station were stored in inactive Units 1/2 Impoundment and the excavated Unit 3A/B Impoundments. The inactive Units 1/2 Impoundment are situated in the northeast of the facility and the inactive Unit 3A/B Impoundments are located at the northwest end of the plant property as shown on Figure 2.

The former Unit 3A/B Impoundments originally consisted of two adjacent impoundments, consisting of engineered, clay-lined, above-ground ponds which were built over historically deposited ash from Boiler Units 1 & 2. The former impoundments were separated from each other by a 10-foot-wide earthen dike and had dimensions of 175 to 190 feet long by 71 to 80 feet wide with an approximate surface area of 0.2 and 0.3 acres for the east and west ponds, respectively. Although the former coal-fired power generation facility ceased operations in February 2020, the Site continued to use the impoundments to clean out the hoppers, vessels, etc. prior to demolition of the buildings. In July 2020, following the clean out procedures, the Site ceased CCR waste disposal in the Unit 3A/B Impoundments. CCR materials were removed in December 2020, with the center embankment separating the ponds being removed, and thus a single inactive impoundment remains. The berm surrounding the pond remains intact except for the south side of the berm, which was removed as part of the excavation. The berms surrounding the east and west sides of the former impoundment range in elevation from 590.8 feet to 593.3 feet and 591.4 feet to 592.5 feet, respectively. The north berm ranges in elevation from 593.0 feet to 594.9 feet. The south remaining berm ranges in elevation from 585.5 feet to 592.2 feet.
